TRADITIONAL ASEISMIC TECHNIQUES IN GREECE

Abstract

This paper is trying to describe some characteristic aseismic traditional techniques in Greece and to formulate their basic principles.

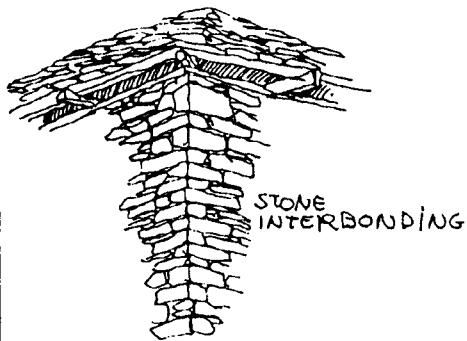
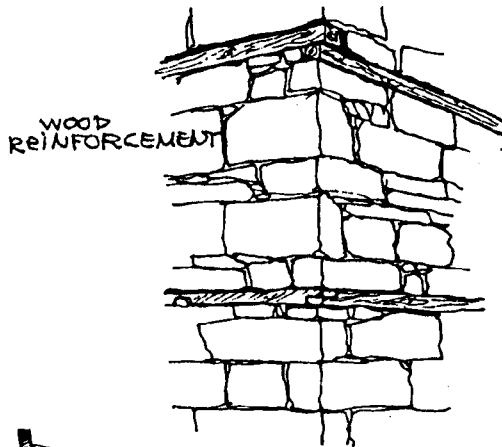
FIG. 4 - CONNECTION OF THE WALLS AT THE CORNERS OF THE BUILDING.

HOUSE OF THASSOS ISLAND
WITH WOOD REINFORCED MASONRY AT LOWER
FLOOR AND WOOD FRAMED (STONE INFILLED)
WALLS OF THE UPPER FLOOR (19TH CENT.)

Better interbonding of the stones at the corners, continuity of the horizontal reinforcement zones (usually in timber) by careful connections at the corners and the use of special iron tie-rods took place during the centuries (Fig. 4).
